**NPDES
Inspection Report**

**Idaho Forest Group, LLC
(NPDES Permit #: IDR05C979)**

Athol, Idaho

July 16, 2015

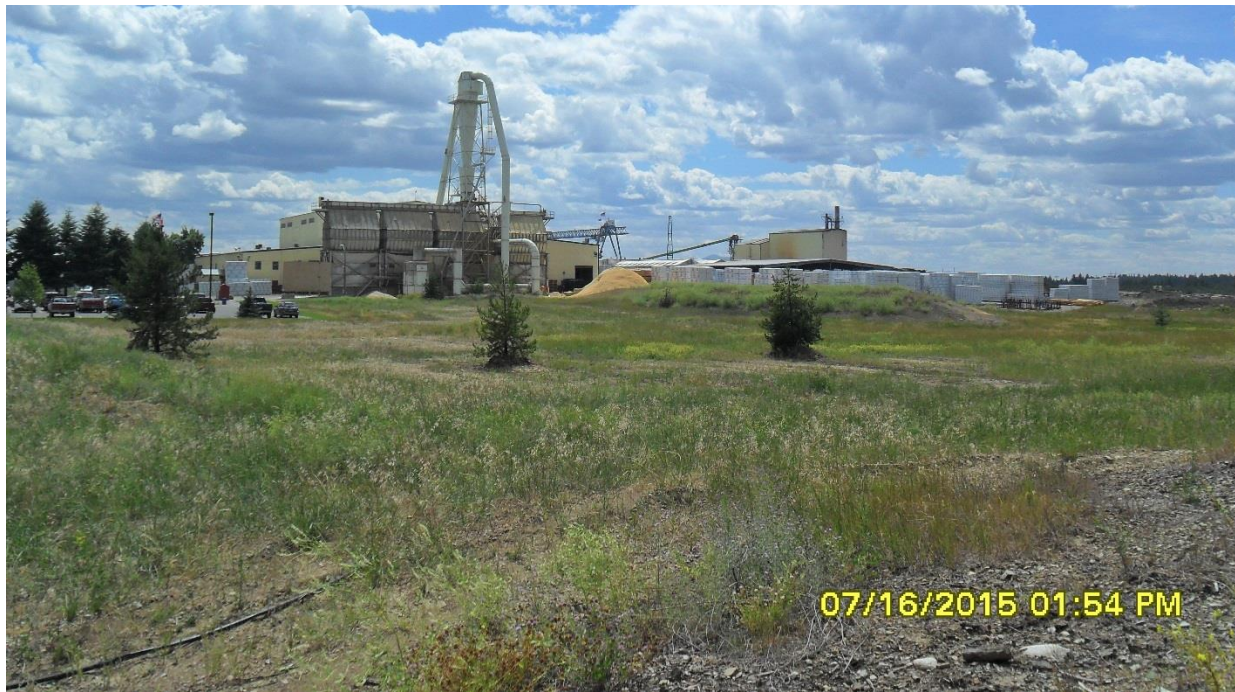
1. Southwesterly view of the facility from the northeast corner of the property. Camera photo # SAM 1900.

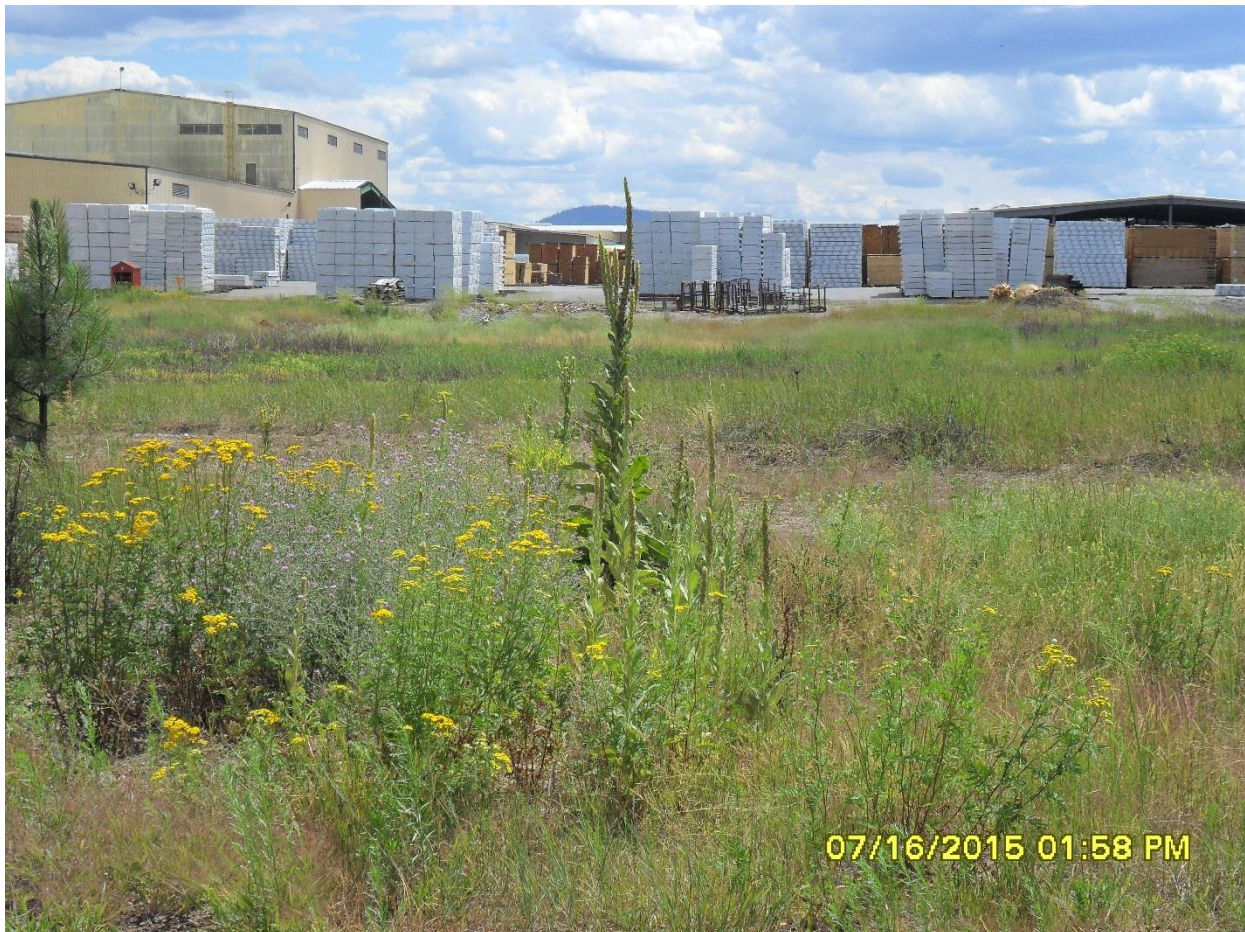
2. Southerly view of the facility from the northern portion of the property. Note the low spot in the foreground which collects runoff from the finished product storage area shown in the background. Camera photo # SAM 1901.

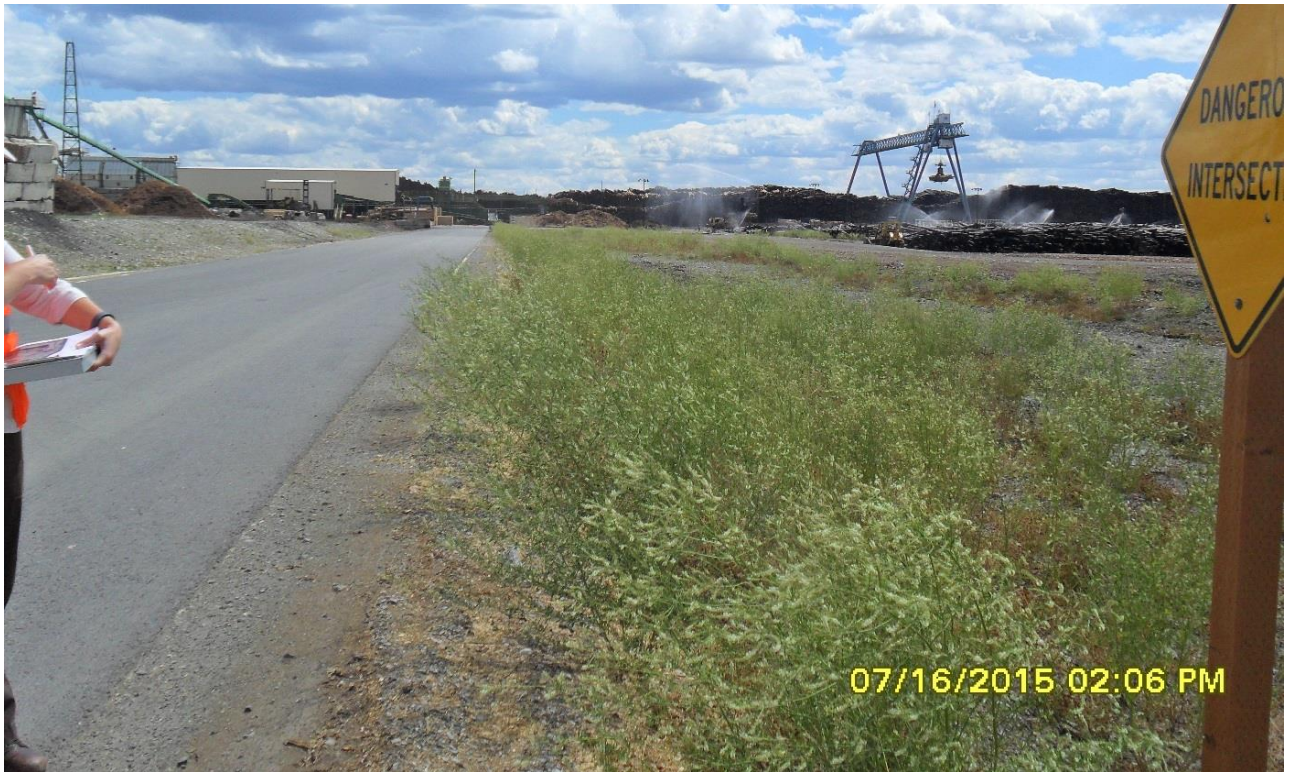
3. Southerly view showing the southern portion of the swale located in the center of the property just west of the building complex. This swale is located just to the right of the road in the photograph. Camera photo # SAM 1903.

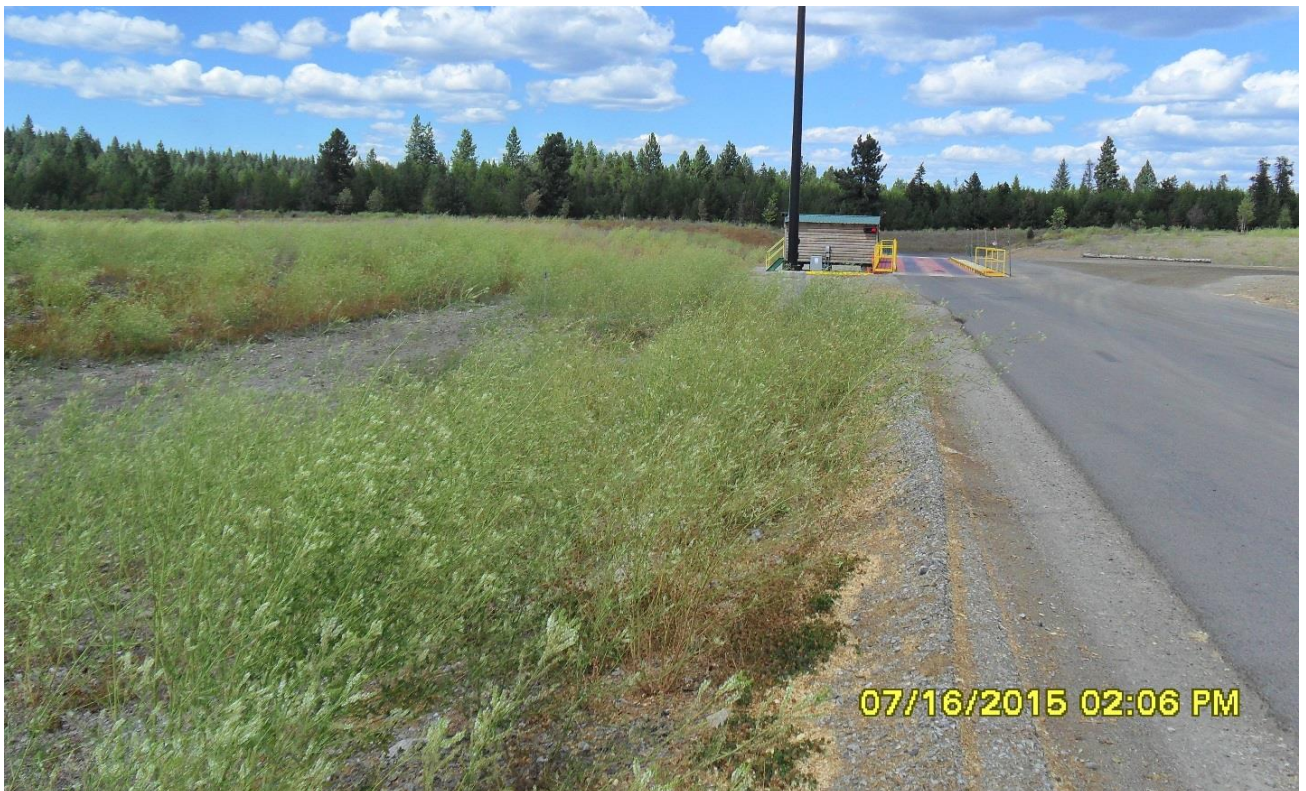
4. Northerly view showing the northern portion of the swale located in the center of the property just west of the building complex. This swale is located just to the left of the road in the photograph. Camera photo # SAM 1904.

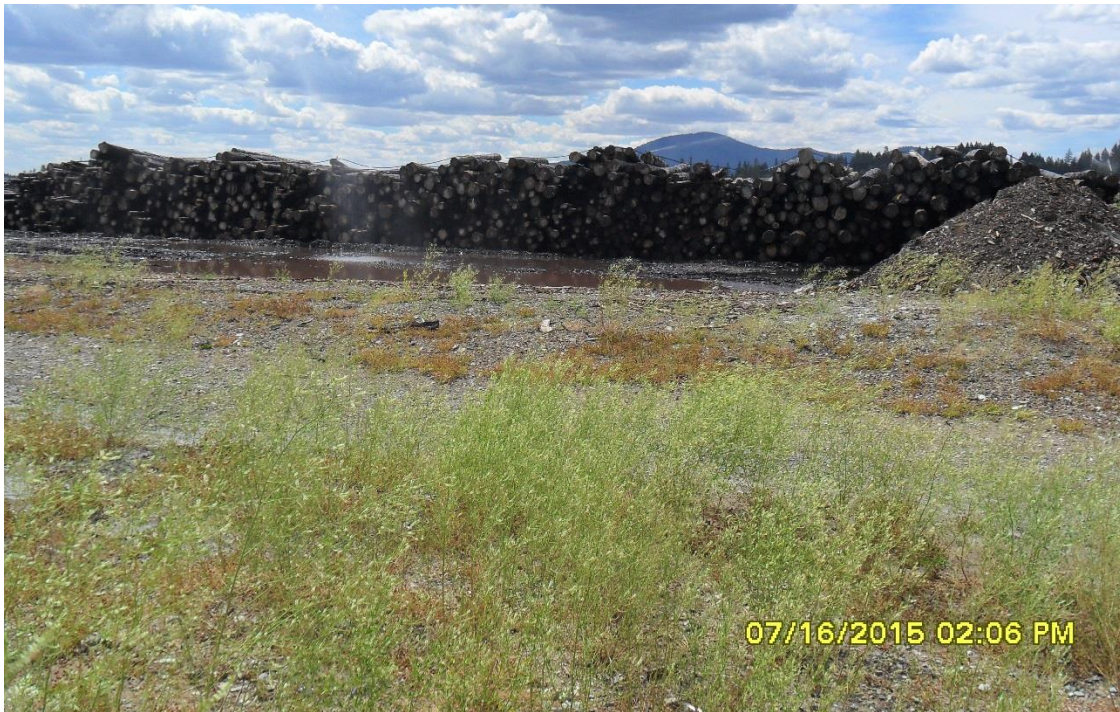
5. Westerly view of one of the log spraying decks on the property. This spray deck is located just west of the swale on the center of the property. Note the swale in the foreground. Camera photo # SAM 1905.

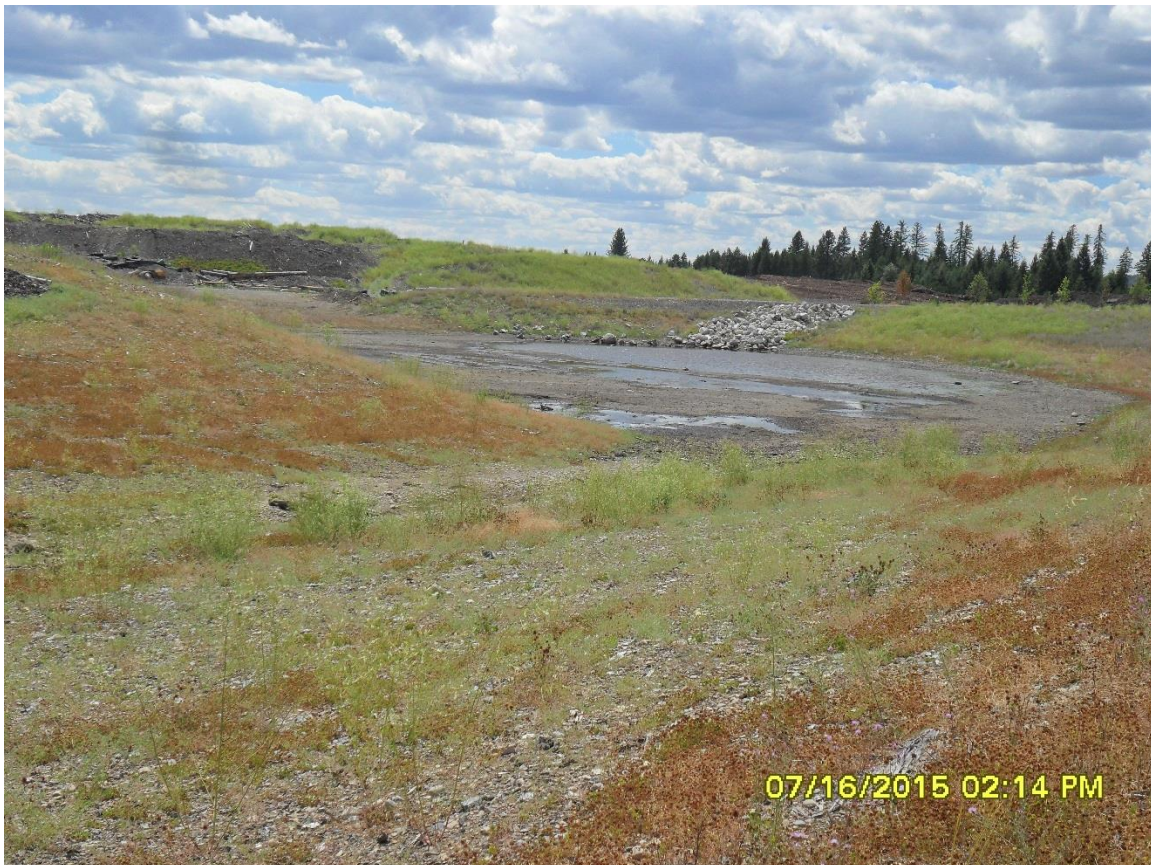
6. Southwesterly view showing the stormwater pond located near the northwest corner of the facility. Camera photo # SAM 1909.

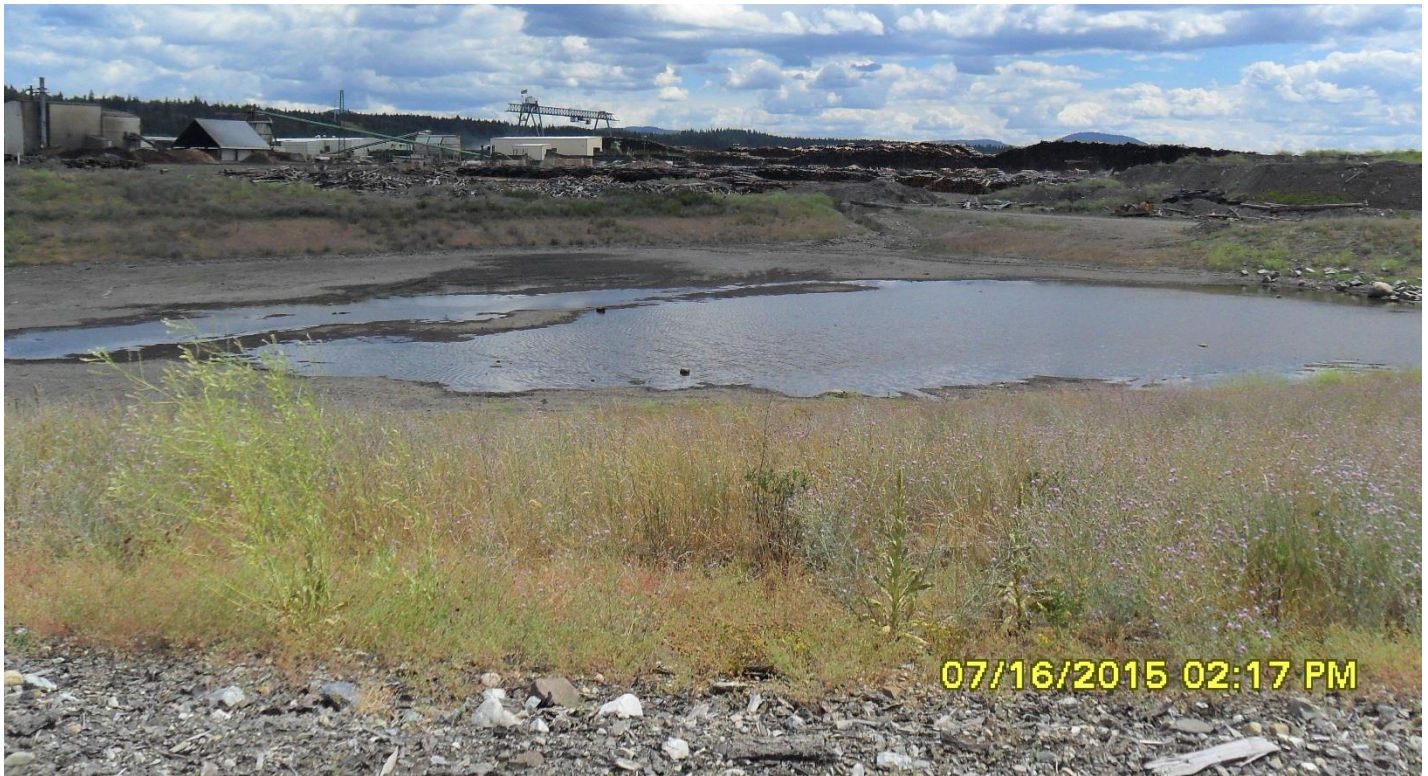
7. Southeasterly view taken from the northwest corner of the property. Note the stormwater pond in the foreground and the processing facility in the background. Camera photo # SAM 1910.

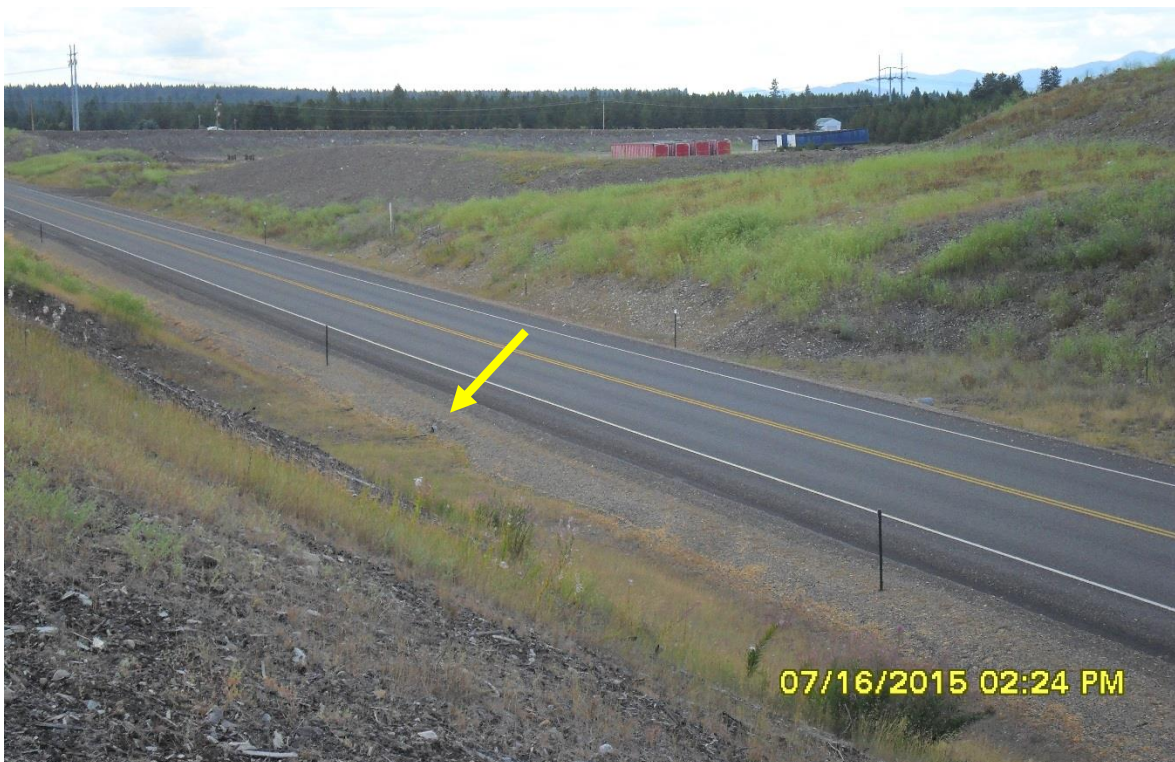
8. Southwesterly view showing the roadway along the west side of the property. Note the culvert between the roadway and the berm along the western property boundary (indicated by the yellow arrow). This culvert marks the low spot in this roadside drainage ditch system. If water from the facility flowed into this ditch system it would likely accumulate in this low spot. Camera photo # SAM 1911.

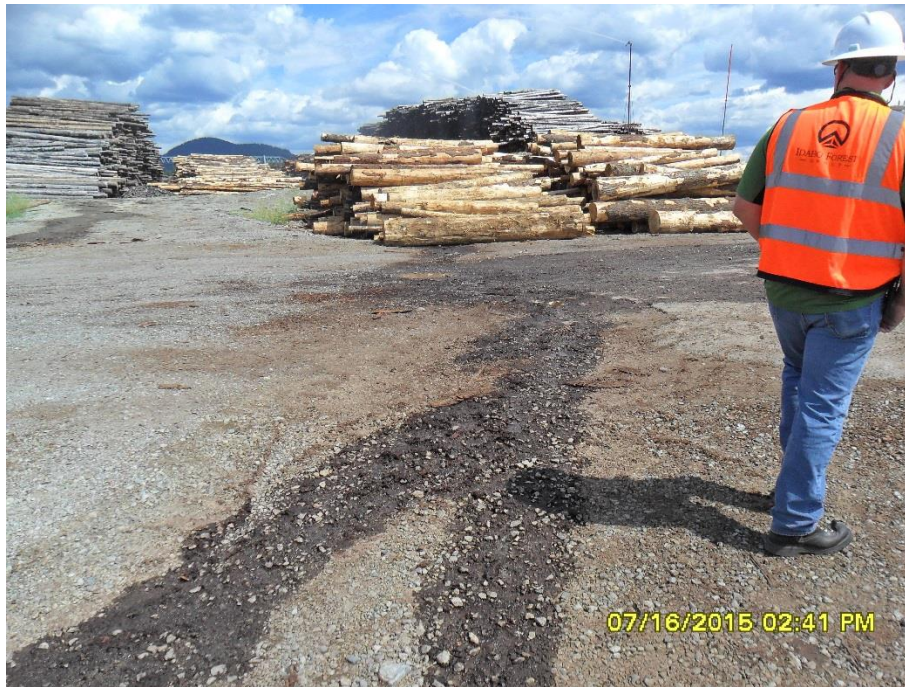
9. Easterly view from an entrance to the site near the southwest corner of the facility. Note the wet path in the gravel leading from the facility. According to facility representatives, this water is likely coming from the water trucks that wet the pavement in the area for dust suppression. This water is traveling in the direction of the roadside ditch seen in the previous picture. Camera photo # SAM 1918.

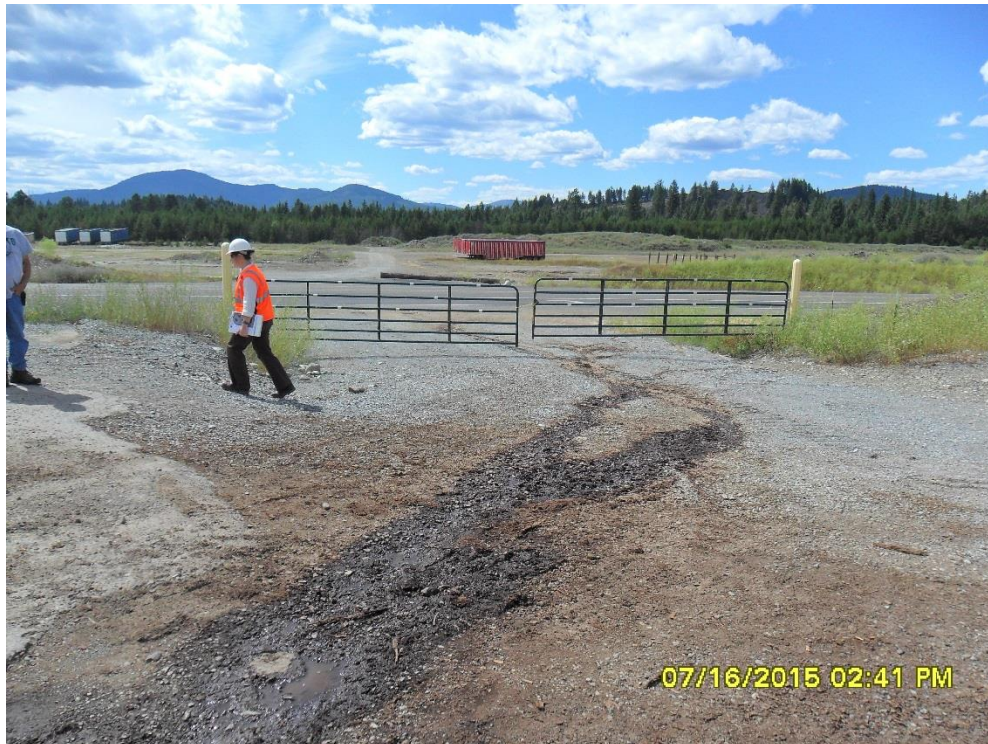
10. Looking in the opposite of the previous picture this is a westerly view from an entrance to the site near the southwest corner of the facility. Note the wet path in the gravel leading from the facility. According to facility representatives, this water is likely coming from the water trucks that wet the pavement in the area for dust suppression. Water seen here is leading to the roadside ditch seen in photograph 8. Camera photo # SAM 1919.
